A/C System Gauge Pressures #7, Section 12.3.4

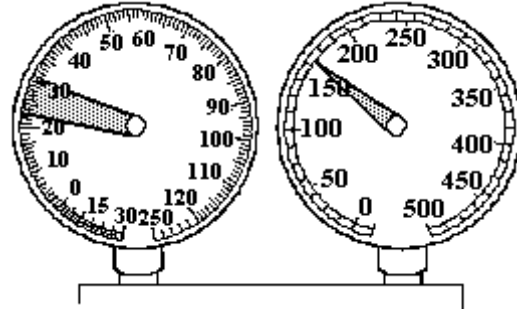
As the gauge set was connected to this R-134a, CCOT system, the pressures were normal. When the system was started, the pressures changed, and after 5 minutes, they stabilized to those shown. The air entering the condenser is at 95° F. The line downstream from the orifice tube is cool with frost at the tube, but the accumulator and suction line are warm. The compressor "short cycles", and when the compressor cycles in, the low side pressure drops rapidly. The in-car air discharge is warm.

1. Low side pressure should be 32-50.  
The system pressure is Low.
2. High side pressure should be 150-310.  
The system pressure is Normal.
3. Expansion tube outlet temperature should be Cold, not frosty
4. Accumulator temperature should be Cold.
5. Suction line temperature should be Cold.
6. Compressor cycle rate should be Cycle normally
7. In-car air discharge temperature should be Cool/cold.
8. This problem is probably caused by: plugged orifice tube
9. The procedure to correct this problem is: 1 Recover refrigerant, 2 Remove and replace orifice tube, 3. Recycle refrigerant, 4. Evacuate system, 5. Charge system, 6. Check for refrigerant leaks, 7. Confirm proper operation.

**Note to instructor using WS 19:** This work sheet describes a typical A/C problem that technicians might encounter. As you probably realize, the pressures and other diagnostic clues are quite variable in the real world, and this work sheet merely gives the student an idea of how problems might show up. The most probable cause of this problem is a plugged orifice tube.
